PRODUCT UPDATE

Air Bleed Filter Orifices

5R110W TorqShift Transmission

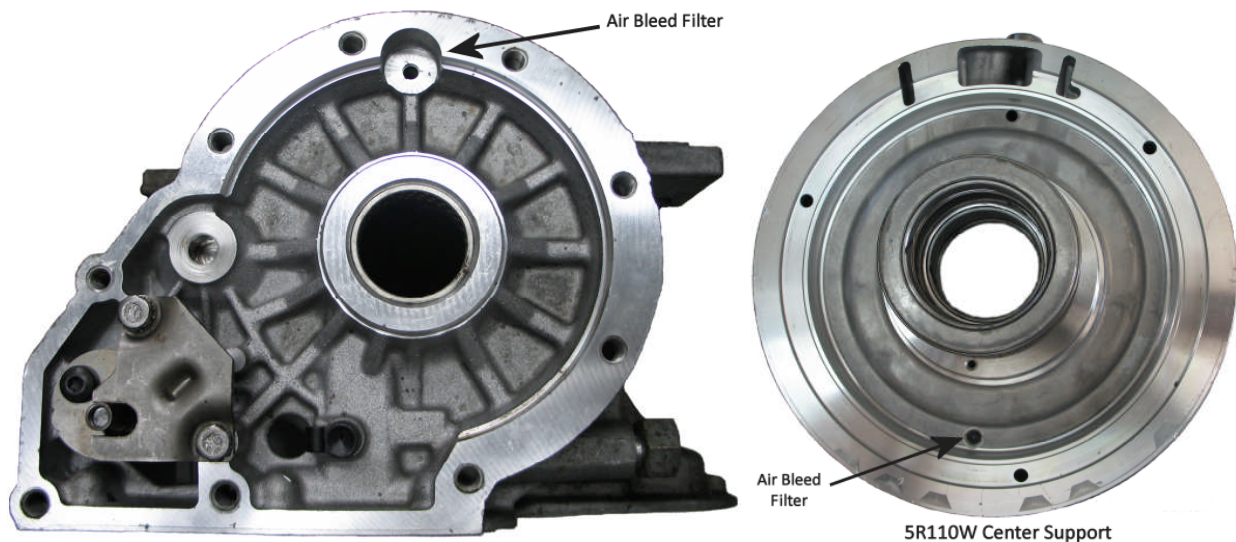
As pictured these filters are located in the rear of the transmission case and the center support and are easily removed with a small punch and hammer and are installed the same way and then staked in place.

These filters can be easily damaged by contamination and heat and should be replaced during the building of this unit.
