5R110W

PROBLEM: The lock up apply rate is too slow with the factory spring causing chatter and potential failure of the lock up clutch lining.

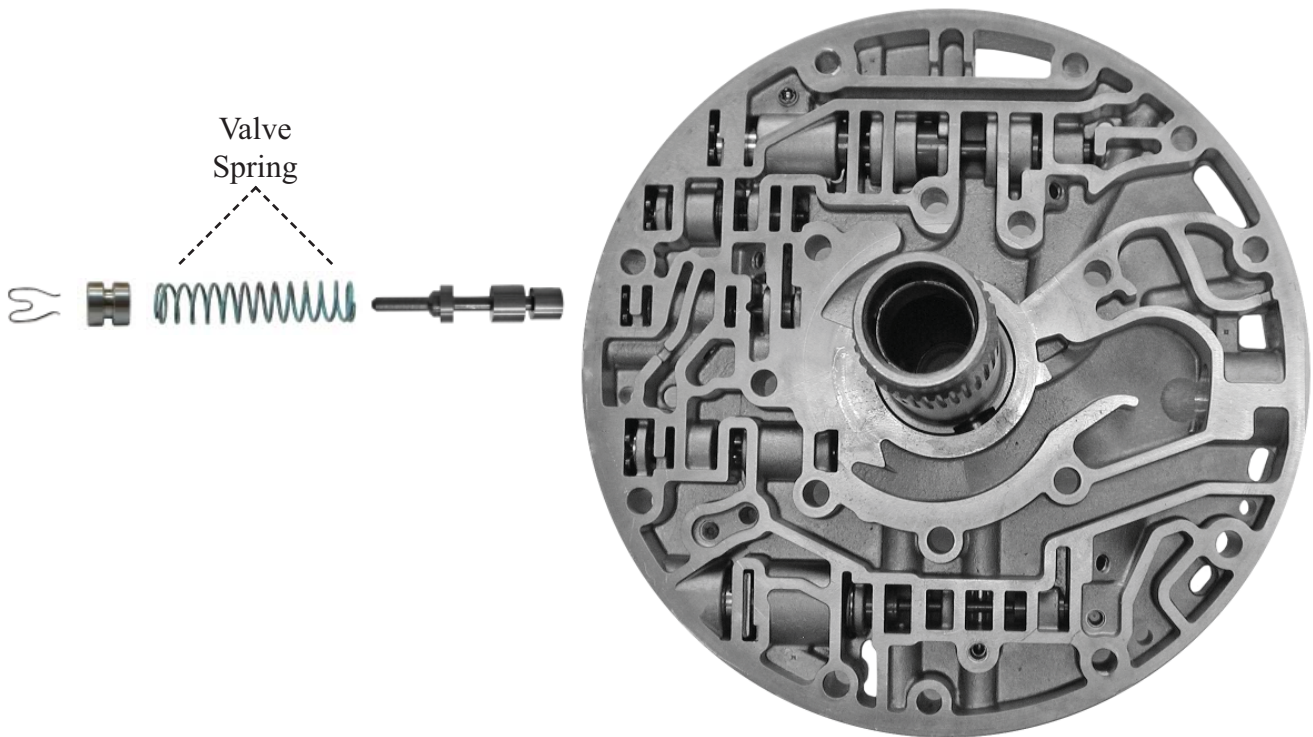
Simply remove the stock spring for the valve line up (see picture below) and replace with the updated spring that is included in this overhaul kit.

SOLUTION: The enclosed spring is designed to improve the apply of the lock up clutch thereby eliminating lock up clutch failure and chatter.

No other modifications are required for this update.
