NP236 – NP246 – NP261 – NP263
Permanent pump wear protection
#BRNY

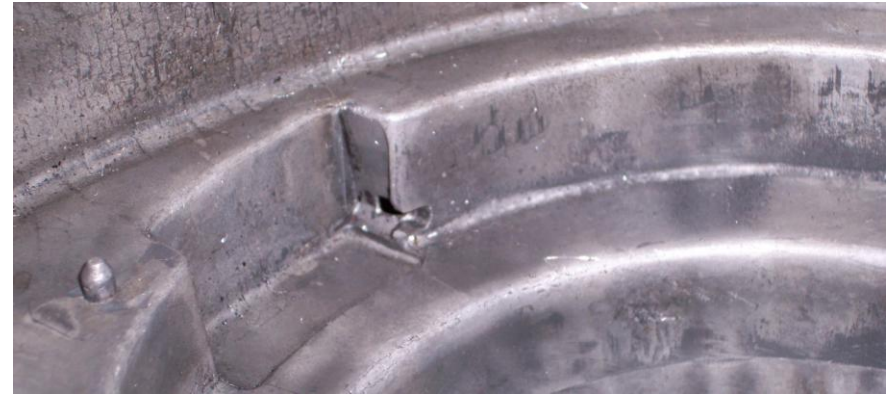
Pump pocket in need of repair

The problem with mere **case replacement** is it **won't solve the problem**. Magnesium cases are soft; aluminum pumps are harder. The problem will come back. Maybe on someone else's watch, but surely you pride yourself in **fixing** problems.

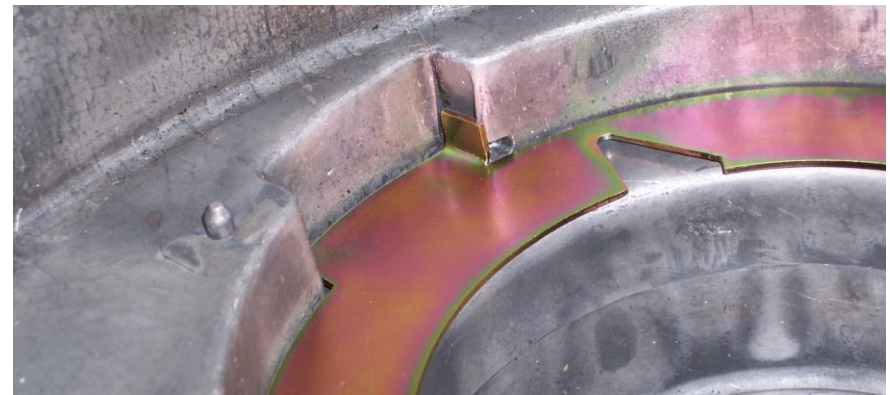
The protector in place, pump's load spread over large surface area

Due to the laser-cut accuracy in the manufacturing of the protector and the original pocket design, endplay is unchanged.

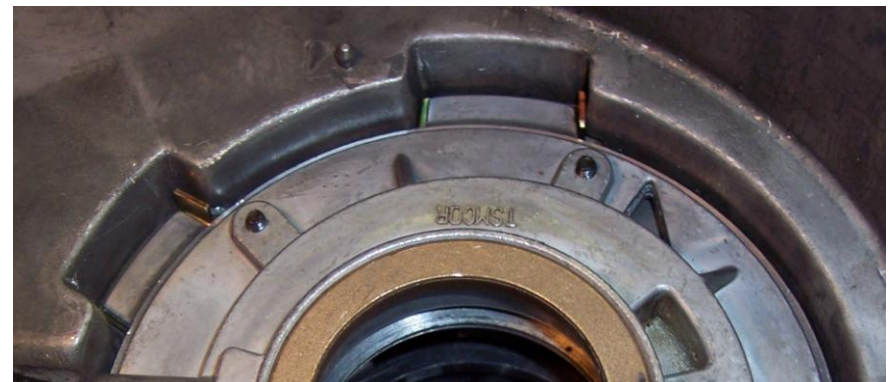
Completed installation, protects all four of pump tabs' cavities
