# ***PRODUCT UPDATE***

## **5R110W TorqShift**

### **Delayed Forward Engagement**

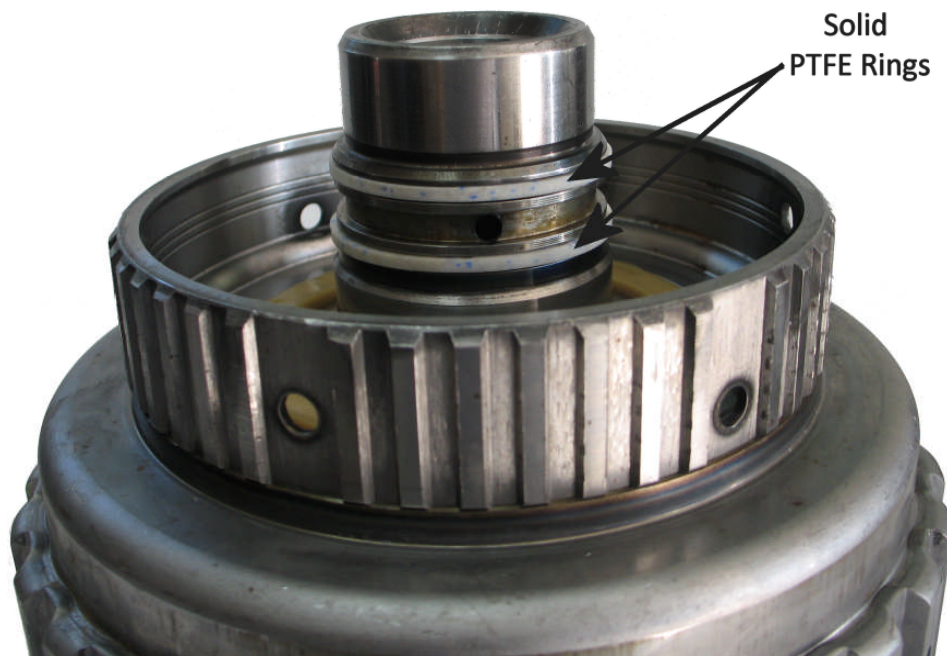
The current production style sealing rings are a known concern to the technical services, as being the cause of *delayed forward engagement*.

The two solid PTFE sealing rings found in this kit use the same installer and resizing tools as the solid PTFE rings used for the 4L60-E stator support for the reverse input clutch.

The solid PTFE ring ensures the best possible seal in this application as it eliminates the need for oil pressure to snap the ring out against the bore which then creates the seal.
